Manhole Inspection Summary

Manhole # S53AA_001MH

Inspection ☐ Is Incomplete Rating: **5) Immediate Attention Required**

Location Address: **601 N.Highland Ave.**

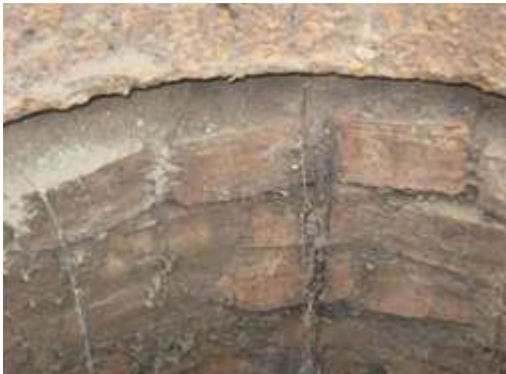
Defect 7

Infiltration: ☐ None ☒ **Joint** ☐ Cracks ☐ Mortar ☐ Roots ☐ Wall

infiltration from large gap at chimney joint

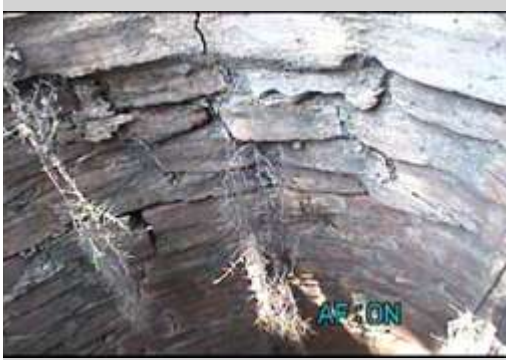
Defect 6

Condition: ☐ Sound ☒ **Cracked** ☒ **Root Intrusion** ☐ Loose Brick ☒ **Deteriorated**

root intrusion at the corbel

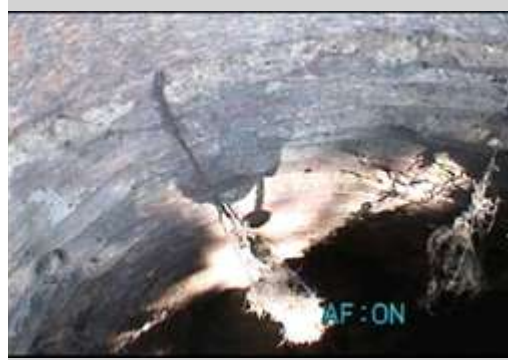
Defect 5

Condition: ☐ Sound ☒ **Cracked** ☒ **Root Intrusion** ☐ Loose Brick ☐ Deteriorated

root intrusion at chimney

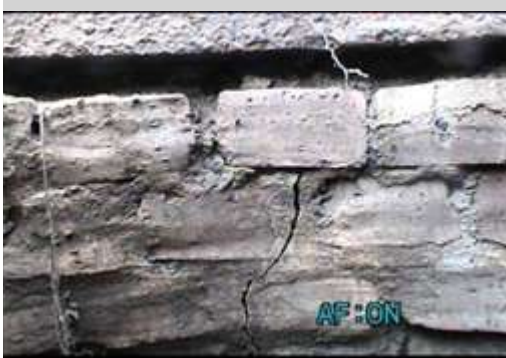
Defect 4

crack in chimney

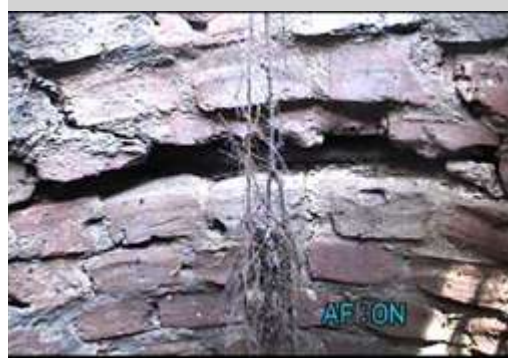
Defect 3

deteriorated corbel

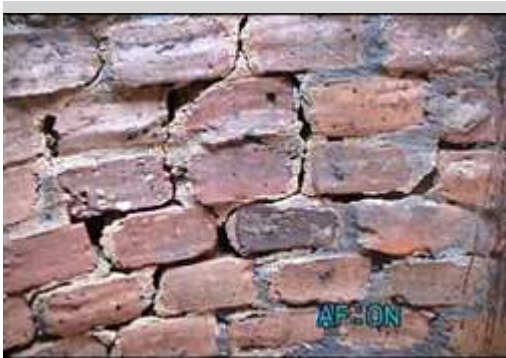
Defect 1

cracks in the corbel

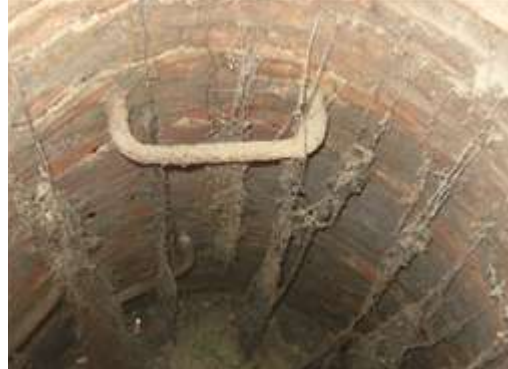
Defect 8

corroded steps

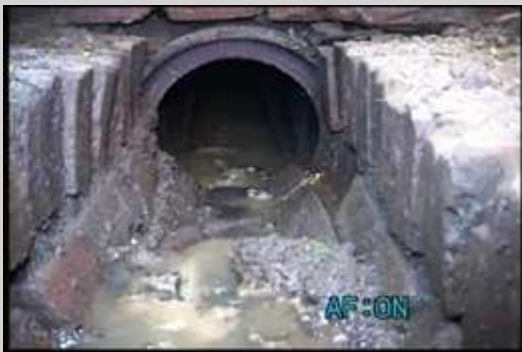
12 O'Clock Outflow

8 in. Circular Gravity Sewer
Pipe Out @ 12 O'Clock

Pipe Height: **8.4** (in.) Rod and Bar (Angled)
Pipe Material: **Clay** ☐ Pipe Lined
Invert Depth: **7.38** (ft.) Flow Characteristics: **None**
Deposits: ☒ None ☐ Mud ☐ Sludge ☐ Debris ☐ Grease
Silt Depth: **0** (in.) Deposits Extent:
Infiltration: **None** Pipe Seal Cond: **Sound**

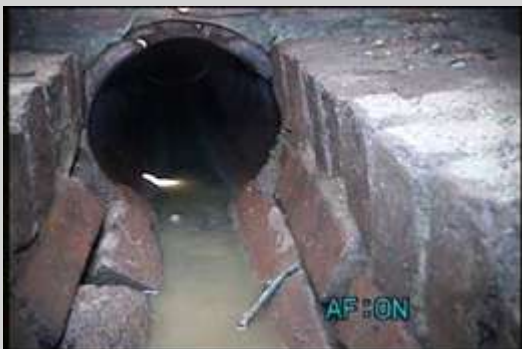
6 O'Clock Inflow

8 in. Circular Gravity Sewer
Pipe In @ 6 O'Clock

Pipe Height: **8.4** (in.) Rod and Bar (Angled)
Pipe Material: **Clay** ☐ Pipe Lined
Invert Depth: **7.00** (ft.) Flow Characteristics: **None**
Deposits: ☒ None ☐ Mud ☐ Sludge ☐ Debris ☐ Grease
Silt Depth: **0** (in.) Deposits Extent:
Infiltration: **None** Pipe Seal Cond: **Sound**
